## Proposed Residential Development

## Stage 1 Road Safety Audit

| <b>Project Title</b> | Proposed Residential Development – N7 Longview Estates |
| <b>Document Title</b> | Road Safety Audit – Stage 1 |

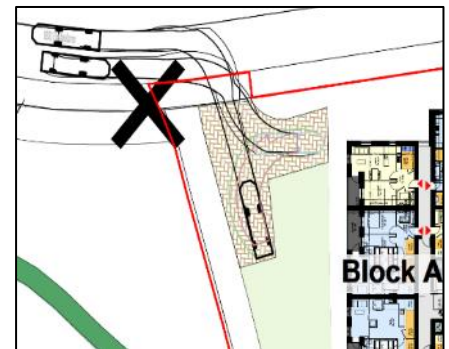
The drawings issued to the audit team shows a turning head at the north western corner of the site. It is unclear from the drawings as to the purpose of this tuning head and frequency of use. If this is to be a permanent feature, the turning head could become an unofficial parking area and lead to collisions between vehicles exiting and pedestrians. Refer to Fig 2.1

The Design team to review layout and the purpose of the junction and turning head.

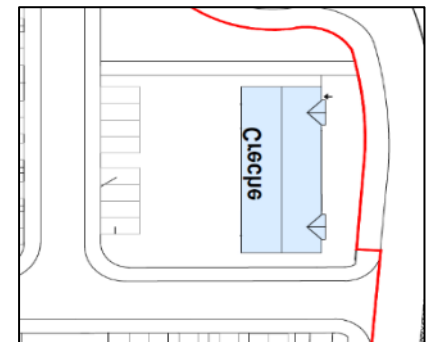
The audit team observed inconsistencies in the drawings in reference to the parking and set-down area for the Creche. Refer to Fig 2.2 as it appears to have no set-down area. If it is proposed to not provide a set down area, this could lead to road safety issues with parked vehicles during the peak drop off and pick up times.

The design team to review the parking and set-down area to ensure the design is in accordance with relevant standards.

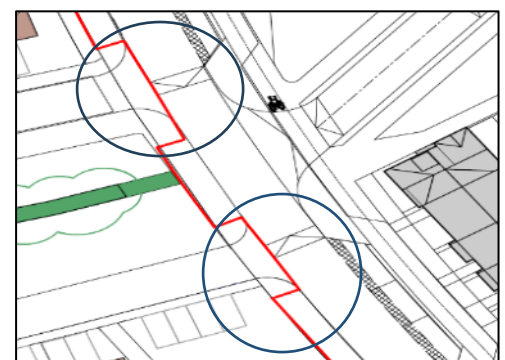
There appears to be a conflict between the 3<sup>rd</sup> and 4<sup>th</sup> entrances and the raised table location shown. The raised table appears to stop in the middle of both junctions (where the parking bays end). The location of these existing parking bays could result in side impact type collisions between vehicles turning out from the car spaces to exit the development and vehicles exiting the new junctions. Refer to Fig 2.3

The design team to review the junctions design and interaction with the existing parking bays to ensure they are designed in accordance with relevant standards.

| | To be completed by the Designer | | | To be Completed by Audit Team Leader |
|---|---|---|---|---|
| 2.3 | Y | N | The raised table has been removed from the junction design. Raised pedestrian crossings positioned to the north and south of the junction are incorporated instead which serve as traffic calming measures for this length of road. The existing parking bays avail of good forward visibility in a low speed environment which should greatly reduce/ remove any risk of side impact collisions between vehicles turning out from the parking spaces and exiting the new junctions. | Yes |

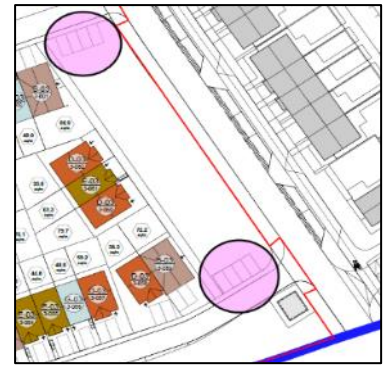
Fig 2.4

The first four parking spots on the proposed South development appear to have very limited visibility to the junction when reversing out of these car parking spaces to vehicles entering the estate. This could lead to rear end shunt type collision between car reversing out of the parking spaces and cars entering and exiting the estate.

The design team to review the sightlines and ensure all visibility are in accordance with relevant standards

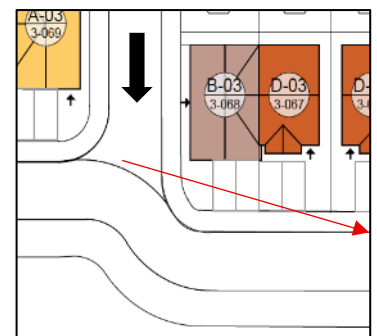
Vehicles traveling south from House 3-08 in the directions of the arrow shown in Fig 2.5 may have their sightlines to vehicles coming from the East restricted by a car parked outside of house 3-068. This could lead vehicle on vehicle side impact type collisions between vehicles pulling out at the junction and vehicle travelling internally within the development.

The design team to ensure adequate sightlines are provided for all junctions within the development.

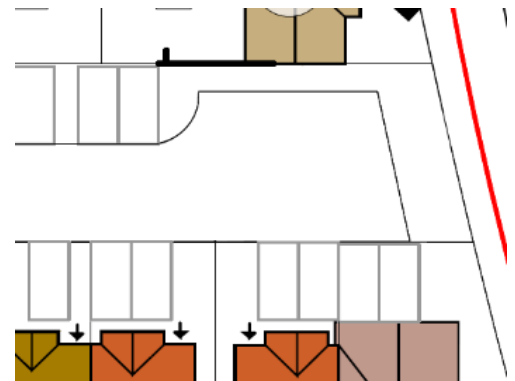
Fig 2.6

The hammer head provided in the site layout at House No 2-040 appears to be very small in nature. An inadequate size turning head could pose a road safety risk to all road users if vehicles are required to undertake multiple manoeuvres to turn around. Refer to Figure 2.6

The design team should run an Auto track at this and all turning points within the development to ensure they are adequately sized for larger vehicles.
